VOLVO TRUCKS

Troubleshooting Guide For Multiband Antenna System

Troubleshooting Part Numbers and Models

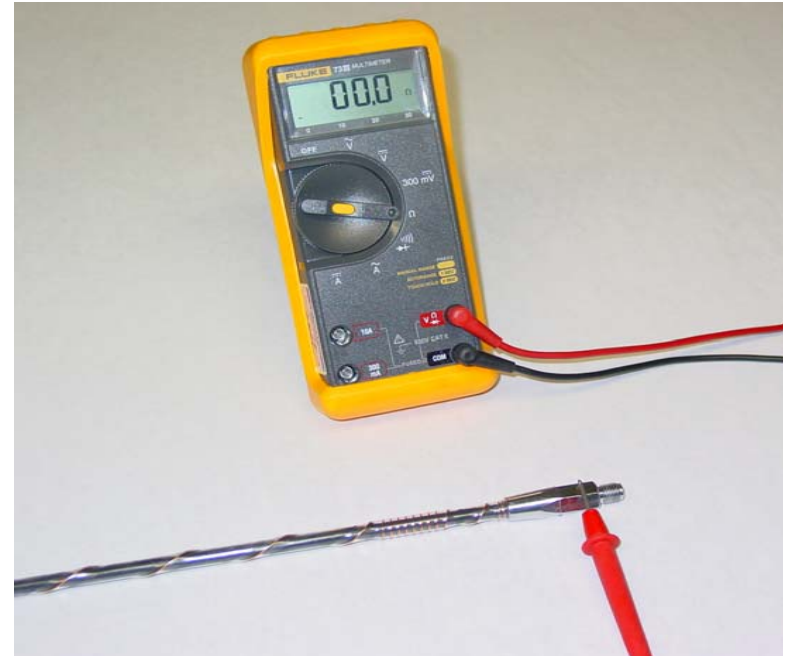
Whip Antenna:

Verify that each whip antenna has a good connection/solder joint at the ferrule end of the antenna. Remove the antenna cap and make a small cut in the heat shrink if required to expose the wire. Do not allow the wire to come out of the slot and uncoil. Using an ohmmeter, check for dc continuity from the antenna ferrule to the tip of the coiled wire at the opposite end of the antenna. While checking for continuity, flex/twist the ferrule end to check for intermittent breaks at the solder joint.

NOTE: The wire is coated with an insulating material. Before performing a continuity check, lightly sand the coiled wire end to expose a small “uncoated” portion near the tip of the antenna.

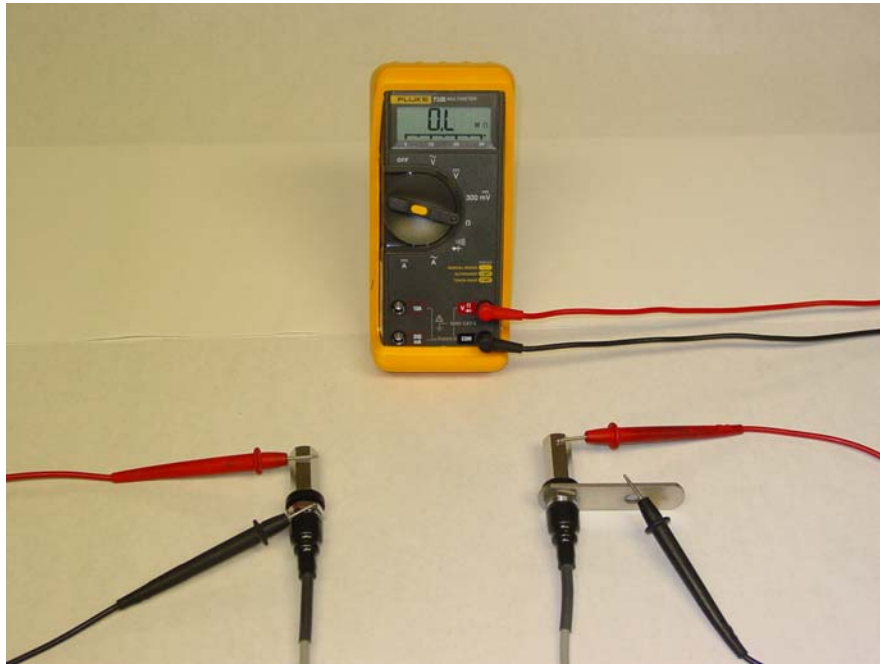
With the CB and AM/FM/WB cables disconnected from the radios, test the following:

Using an ohmmeter, verify that the antenna mount bracket assembly has no dc continuity between the standoff nut and the ground portion.

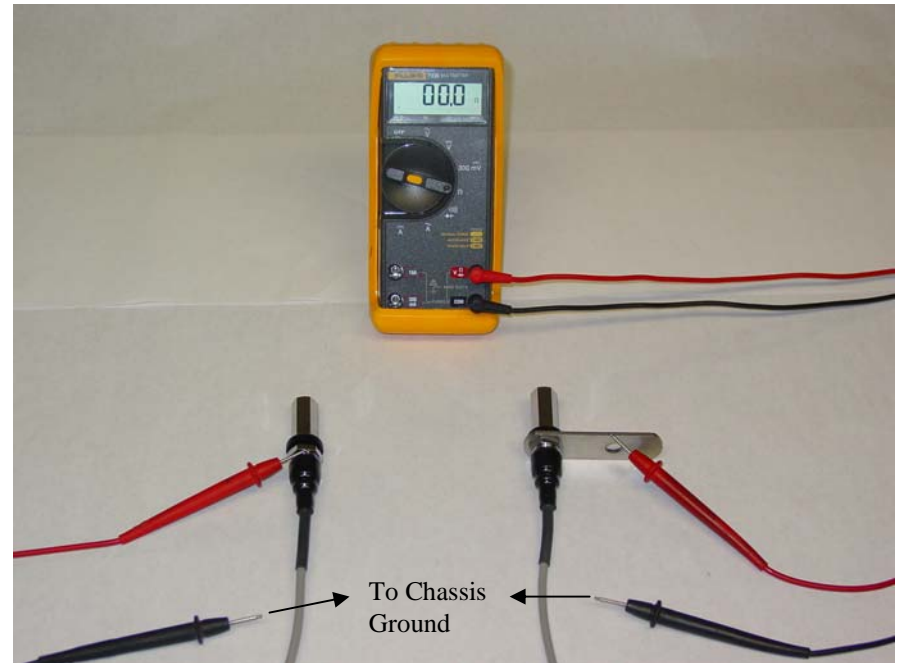
Then verify that the ground portion of the bracket has dc continuity to chassis ground (less than 5 ohms).

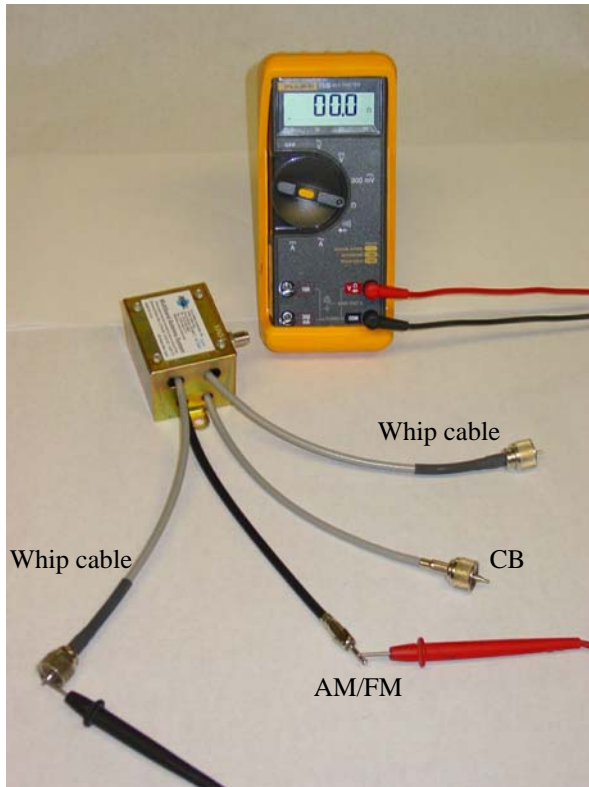
Center to Center

With cables disconnected from the bracket mount assemblies Test from the AM/FM cable center conductor to the whip cable center conductor – dc continuity

*Testing continuity through the CB cable is no longer possible as the internal components do not provide a D.C. path. To verify continuity through the whip antenna cables, checks are made to the AM/FM Motorola connector.

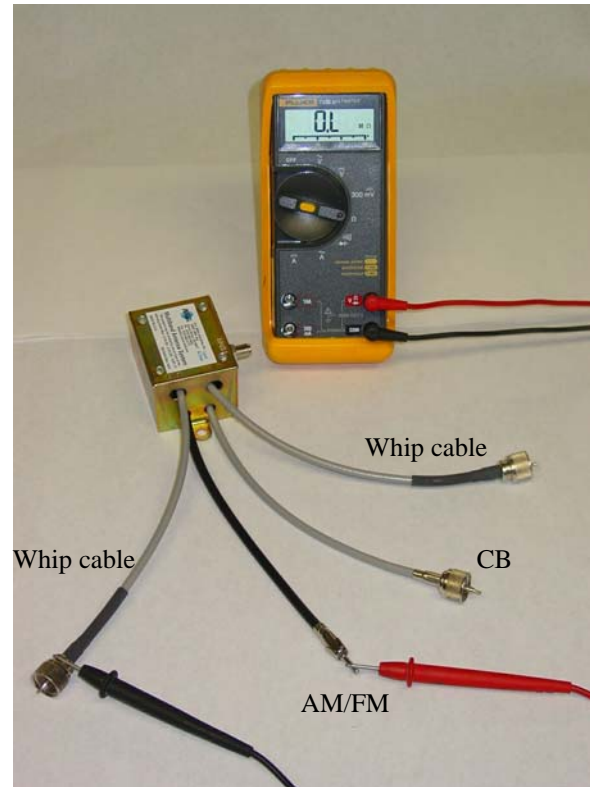
Center to Outer

With cables disconnected from the bracket mount assemblies Test from the AM/FM cable center conductor to the whip cable outer conductor – no dc continuity

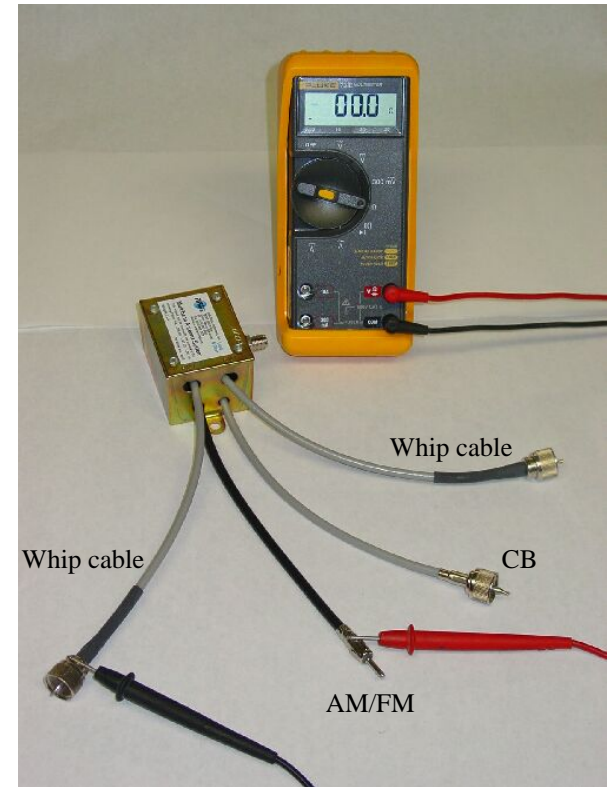
Outer to Outer

With cables disconnected from the bracket mount assemblies Test from the outer shell of the AM/FM cable connector to the whip cable outer conductor – dc continuity
