PETERBILT TRUCKS

Troubleshooting Guide For Multiband Antenna System

Troubleshooting Part Numbers and Models

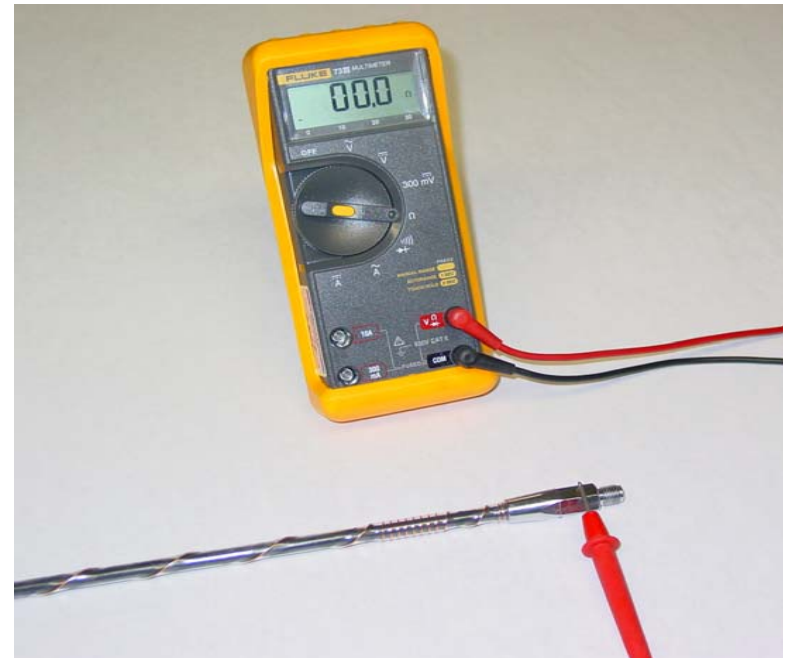
Verify that each whip antenna has a good connection/solder joint at the ferrule end of the antenna. Remove the antenna cap and make a small cut in the heat shrink if required to expose the wire. Do not allow the wire to come out of the slot and uncoil. Using an ohmmeter, check for dc continuity from the antenna ferrule to the tip of the coiled wire at the opposite end of the antenna. While checking for continuity, flex/twist the ferrule end to check for intermittent breaks at the solder joint.

NOTE: The wire is coated with an insulating material. Before performing a continuity check, lightly sand the coiled wire end to expose a small “uncoated” portion near the tip of the antenna.

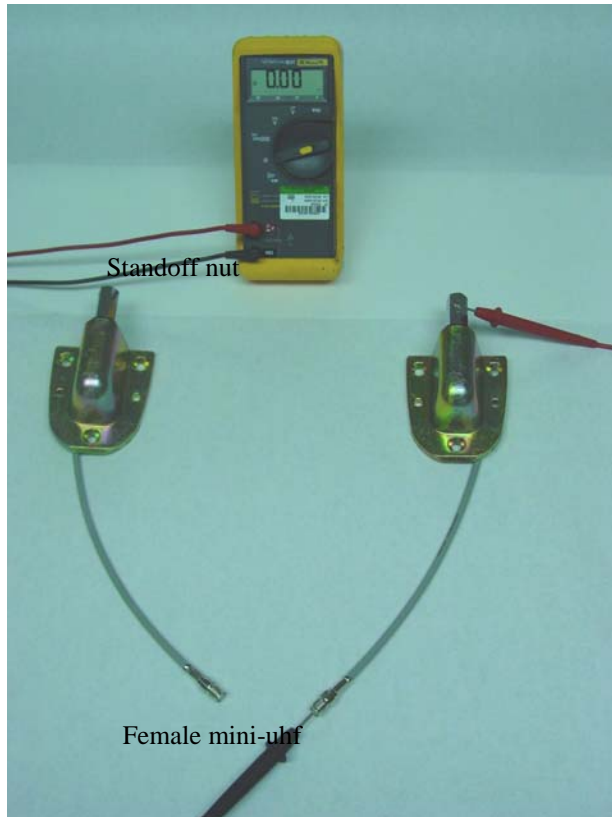
Center to Center

With cables disconnected at the kick panels Test from the center pin of the female mini-uhf connector to the standoff nut – dc continuity (test both bracket assemblies)
